# Defective Transmission Roller Bearing Design

by Tom Endy 2021

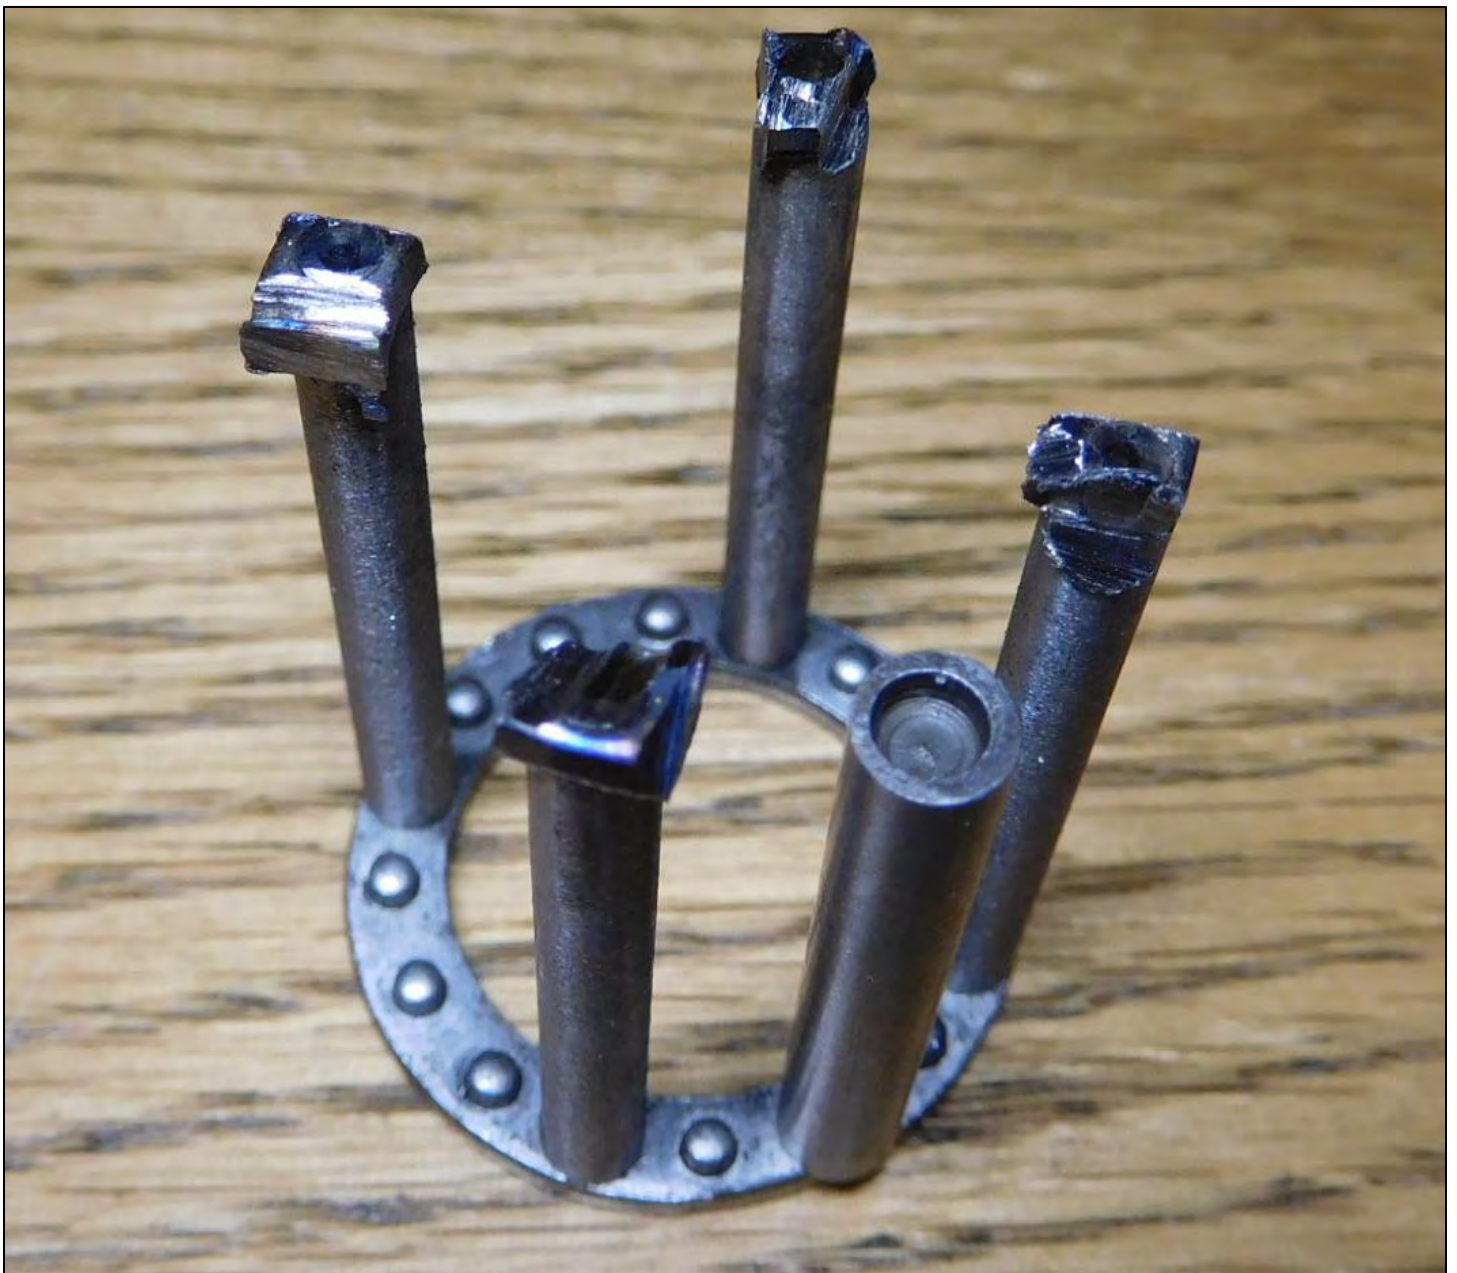
The two Model A roller bearings on the market today, part numbers A-7118 and A-7121, have a short service life due to the change in design. The bearings that were on the market a few years ago were of a different design, but carried the same part number and had an axle at the end of each roller element that protruded through holes drilled into the end caps. The current design has a series of mushrooms stamped into the end caps; the roller elements have holes drilled into both ends of the roller elements that ride on the mushrooms. The photo below shows a disassembled new roller bearing of the current design on the market. Note that the holes in the end of the roller element do not appear to be symmetrical. The bearing has a total of 12 roller elements and four support beams. The four support beams were cut in order to disassemble the bearing. The one single roller element is simply standing on end over a mushroom. Once the roller element wears into the mushroom on the end cap the roller element will become uncaged and the bearing will fail. Most have failed between 300 and one thousand miles.
